ACTIVE CLEANING TECHNIQUE FOR
REMOVING CONTAMINATION FROM OPTICAL
SURFACES IN SPACE

Quarterly Progress Report No. 8

Boeing Aerospace Company
Research and Engineering Division
Seattle, Washington 98124

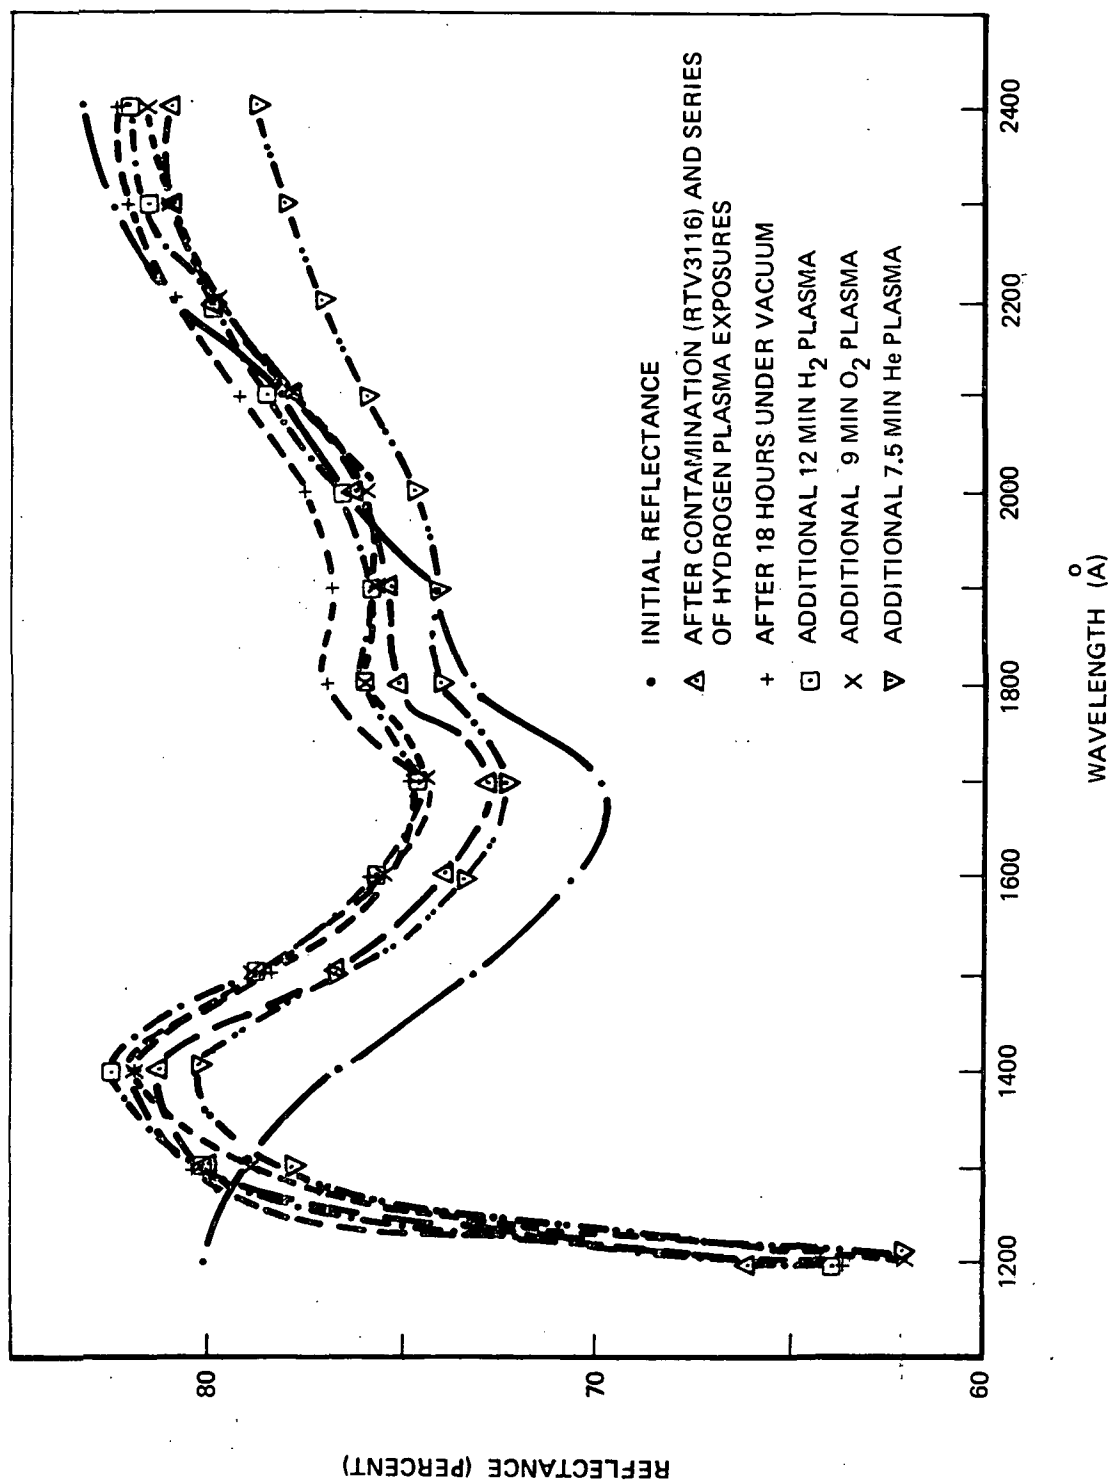
Figure 11: REFLECTANCE DATA FOR MgF₂/Al MIRROR MgF114

A second MgF_2/Al mirror (MgF114) was exposed to the outgas products of RTV3116 for 30 minutes. The QCM response indicated a contaminant film deposition of about $1.5 \times 10^{-6} \text{ gm/cm}^2$. The effects of the contaminant film on the U.V. reflectance are similar to those observed for sample MgF113 (see Figure 10). The data in Figure 10 also indicate that some of contaminant film evaporated, as before, during a 19 hour exposure to vacuum. This sample was subjected to a series of hydrogen plasma exposures of 7.5, 10, 12 and 7.5 minutes. As with the helium plasma exposures of MgF113, the hydrogen plasma exposures increased the reflectance of MgF114 at the shorter wavelengths and decreased it at the longer wavelengths. However the hydrogen plasma produces more restoration at the shorter wavelengths and less degradation at the longer wavelengths. Subsequent to this series of plasma exposures the sample was left under vacuum for 18 hours and then subjected to three additional plasma exposures, (12 minutes using hydrogen, 9 minutes using oxygen and 7.5 minutes using helium). Figure 11 shows the reflectance data for these cases. The hydrogen plasma exposure resulted in a slight improvement at the shorter wavelengths and slight degradation at the longer wavelengths. The oxygen plasma exposure resulted in slight further degradation. The helium plasma exposure produced a significant further degradation of the reflectance.

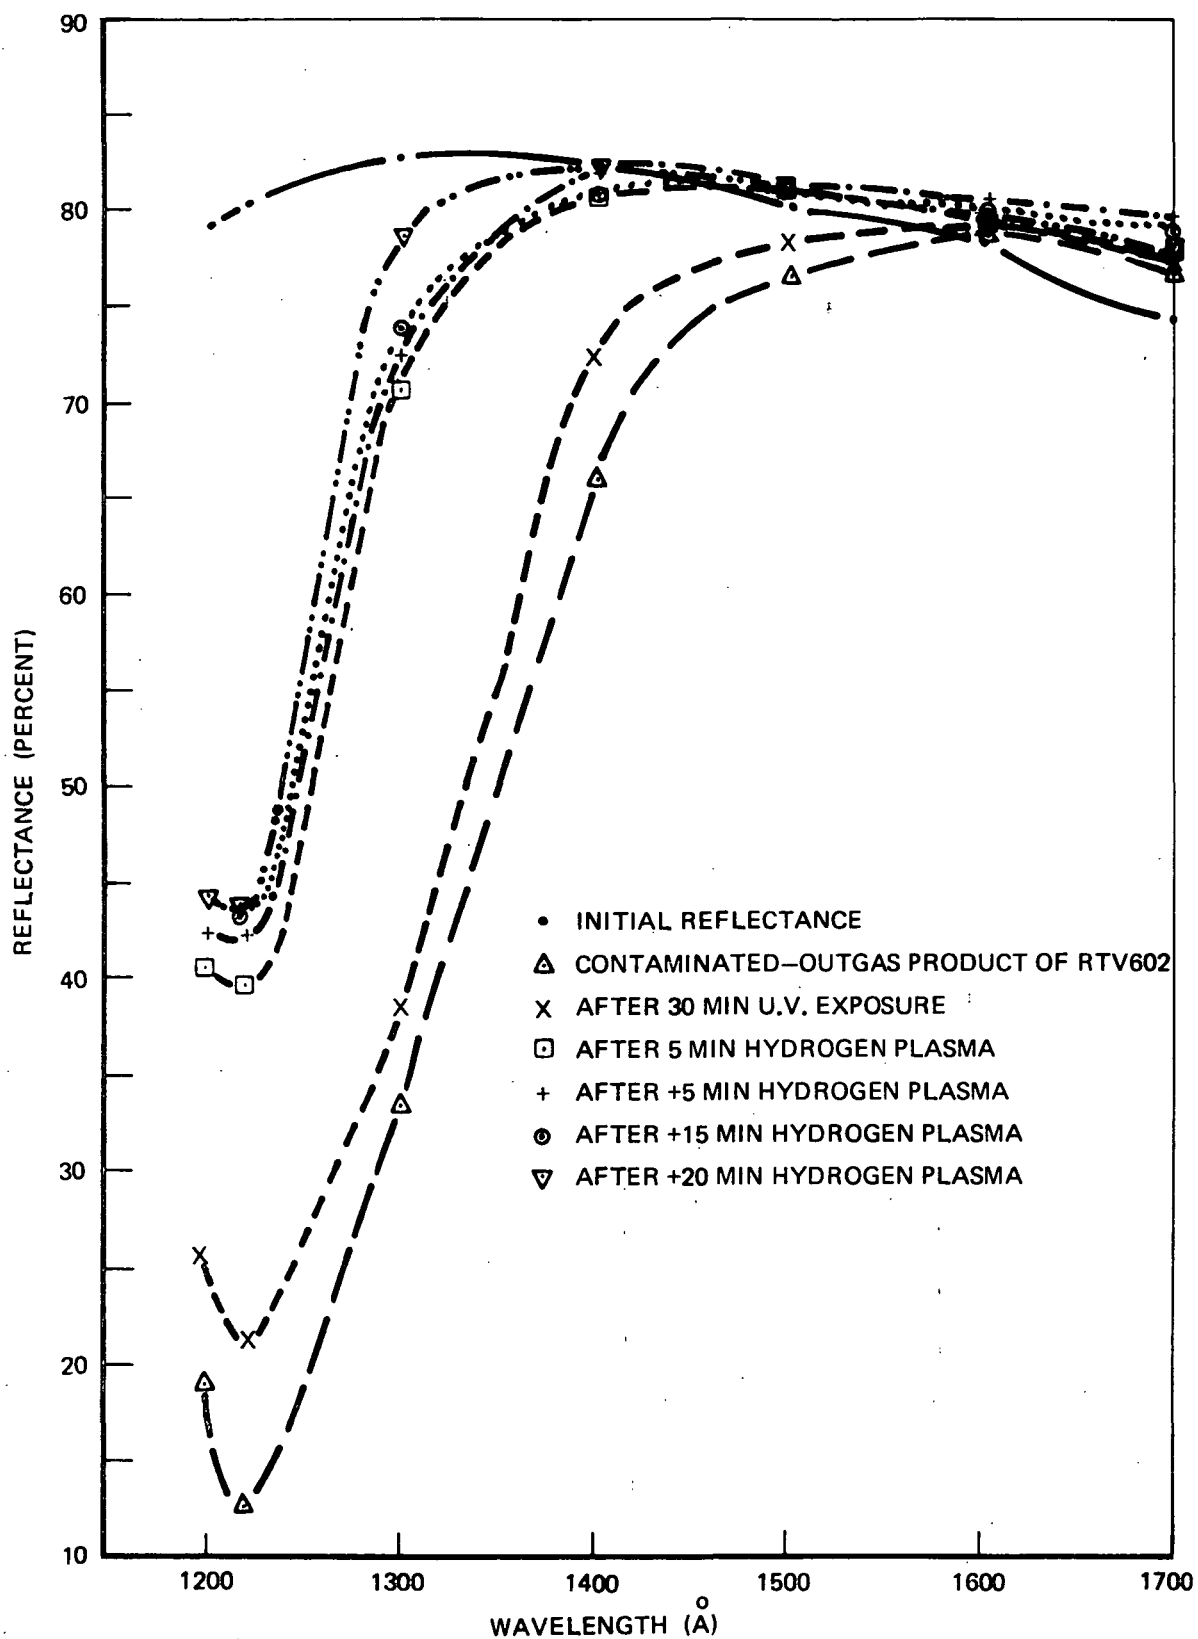
Figure 12: REFLECTANCE DATA FOR MgF_2/Al MIRROR $MgF116$

These initial experiments showed that the U.V. reflectance of MgF_2/Al coated mirrors, contaminated with the outgas products from RTV3116, could be partially restored using helium and hydrogen plasmas. Further experiments were conducted using the outgas products of RTV602 to contaminate MgF_2/Al coated mirrors. The silicone compounds in RTV602 are similar to those in S-13 white paint (a spacecraft coating). These experiments also utilized a sapphire window in the in-situ monochromator to extend the reflectance measurements to 3000 \AA . Two mirrors were used in these tests. The first mirror MgF116 was exposed to the RTV602 outgas products for 27 minutes. The QCM response indicated a contaminant film deposition of about $2.2 \times 10^{-6} \text{ gm/cm}^2$. During this exposure a gold coated glass slide was also contaminated. This slide was placed in the chamber contamination inlet port so that a thick contaminant film would result. Subsequent analysis of this film revealed the presence of dimethylsiloxane. Subsequent to contamination, sample MgF116 was exposed to U.V. radiation for 30 minutes. This exposure produced some restoration of the reflectance. (The reflectance data for MgF116 are shown in Figures 12 and 13). The sample was then subjected to a series of hydrogen plasma exposures. Figure 12 shows that these exposures produced a significant restoration of the reflectance at shorter wavelengths and Figure 13 shows a progressive degradation at the longer wavelengths. Two additional hydrogen plasma exposures totaling 52.5 minutes produced little change in the shorter wavelengths and slight further degradation at the longer wavelengths. (These data are not shown in Figures 12 and 13).

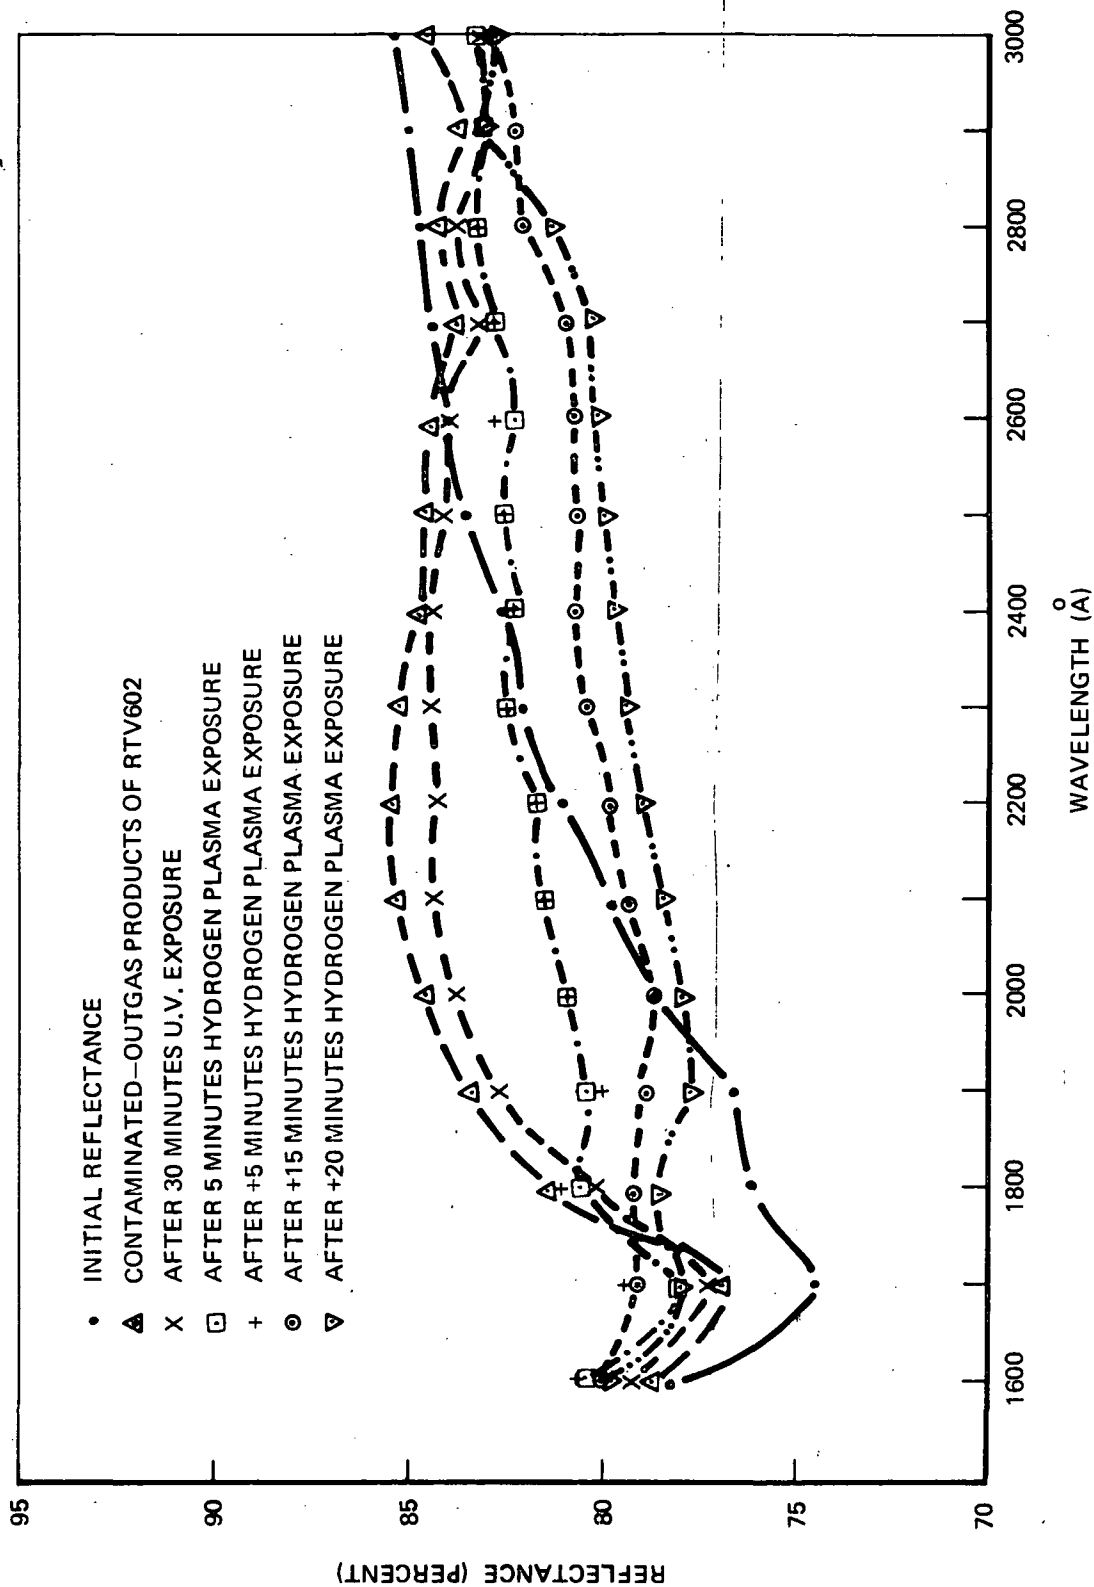
Figure 13: REFLECTANCE DATA FOR MgF_2/Al MIRROR MgF116

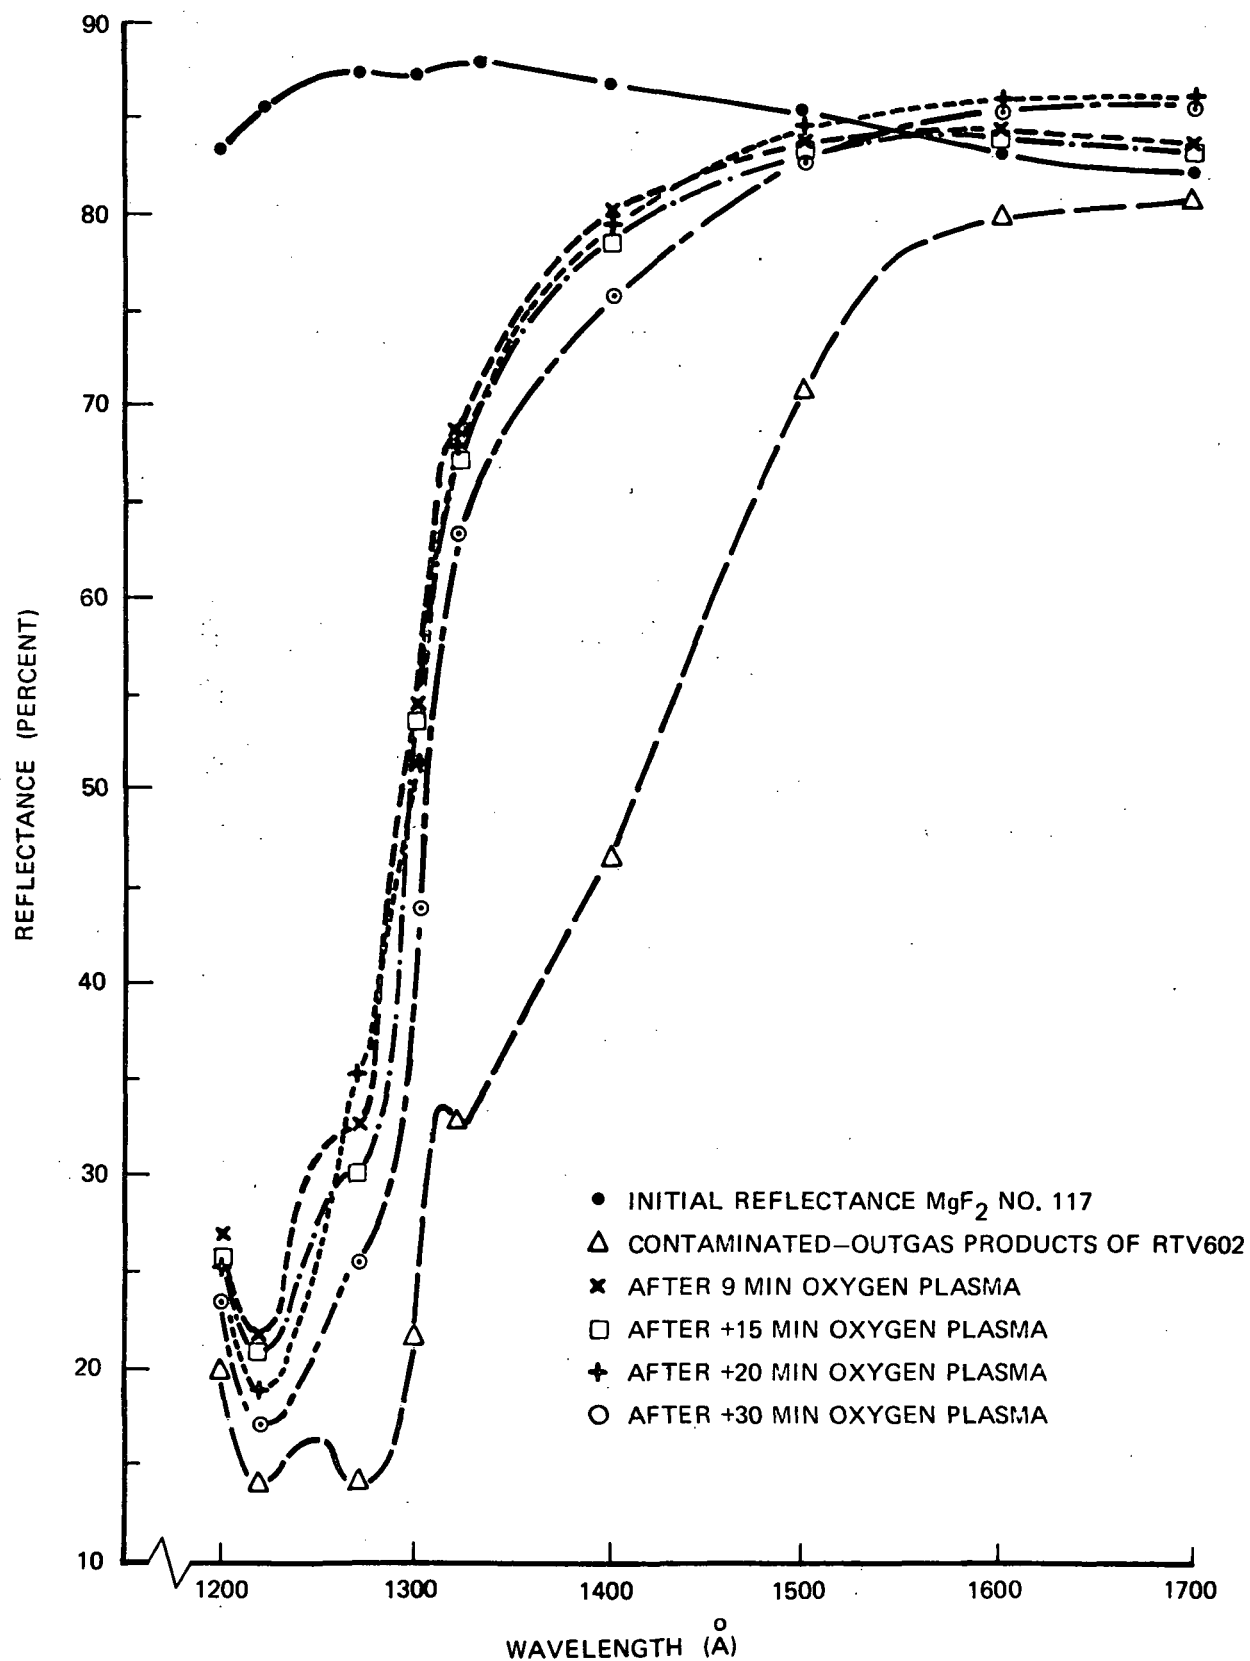
Figure 14: REFLECTANCE DATA FOR MgF_2/Al MIRROR MgF117

was above 1μ . At first this pressure was attributed to outgassing effects, however, a system leak was discovered later. After sealing the leak the sample contamination procedure was repeated. A 30 minute exposure then resulted in a total indicated film deposition of about $3 \times 10^{-6} \text{ gm/cm}^2$. The sample was then exposed to a series of oxygen plasma exposures. Figures 14 and 15 show the reflectance data for mirror MgF117. The degraded reflectance, prior to plasma exposure, shows minimums at about 1220, 1270 and 1320 Å, whereas, that for MgF116 showed only the 1220 Å minimum. This difference might be explained by the fact that, after contamination, MgF116 was left under vacuum and then let up to air prior to the reflectance measurement, or by the fact that MgF117 had a somewhat thicker contaminant film. Figure 14 shows that the minimums at 1270 and 1320 Å were removed by oxygen plasma exposure, however, the restoration at 1220 Å was much less than that obtained for MgF116 using hydrogen plasma exposure. The data shown in Figure 14 also show that the reflectance at the shorter wavelengths is initially increased and then progressively degrades with continued exposure to an oxygen plasma. Figure 15 shows somewhat the opposite effect at the longer wavelengths.

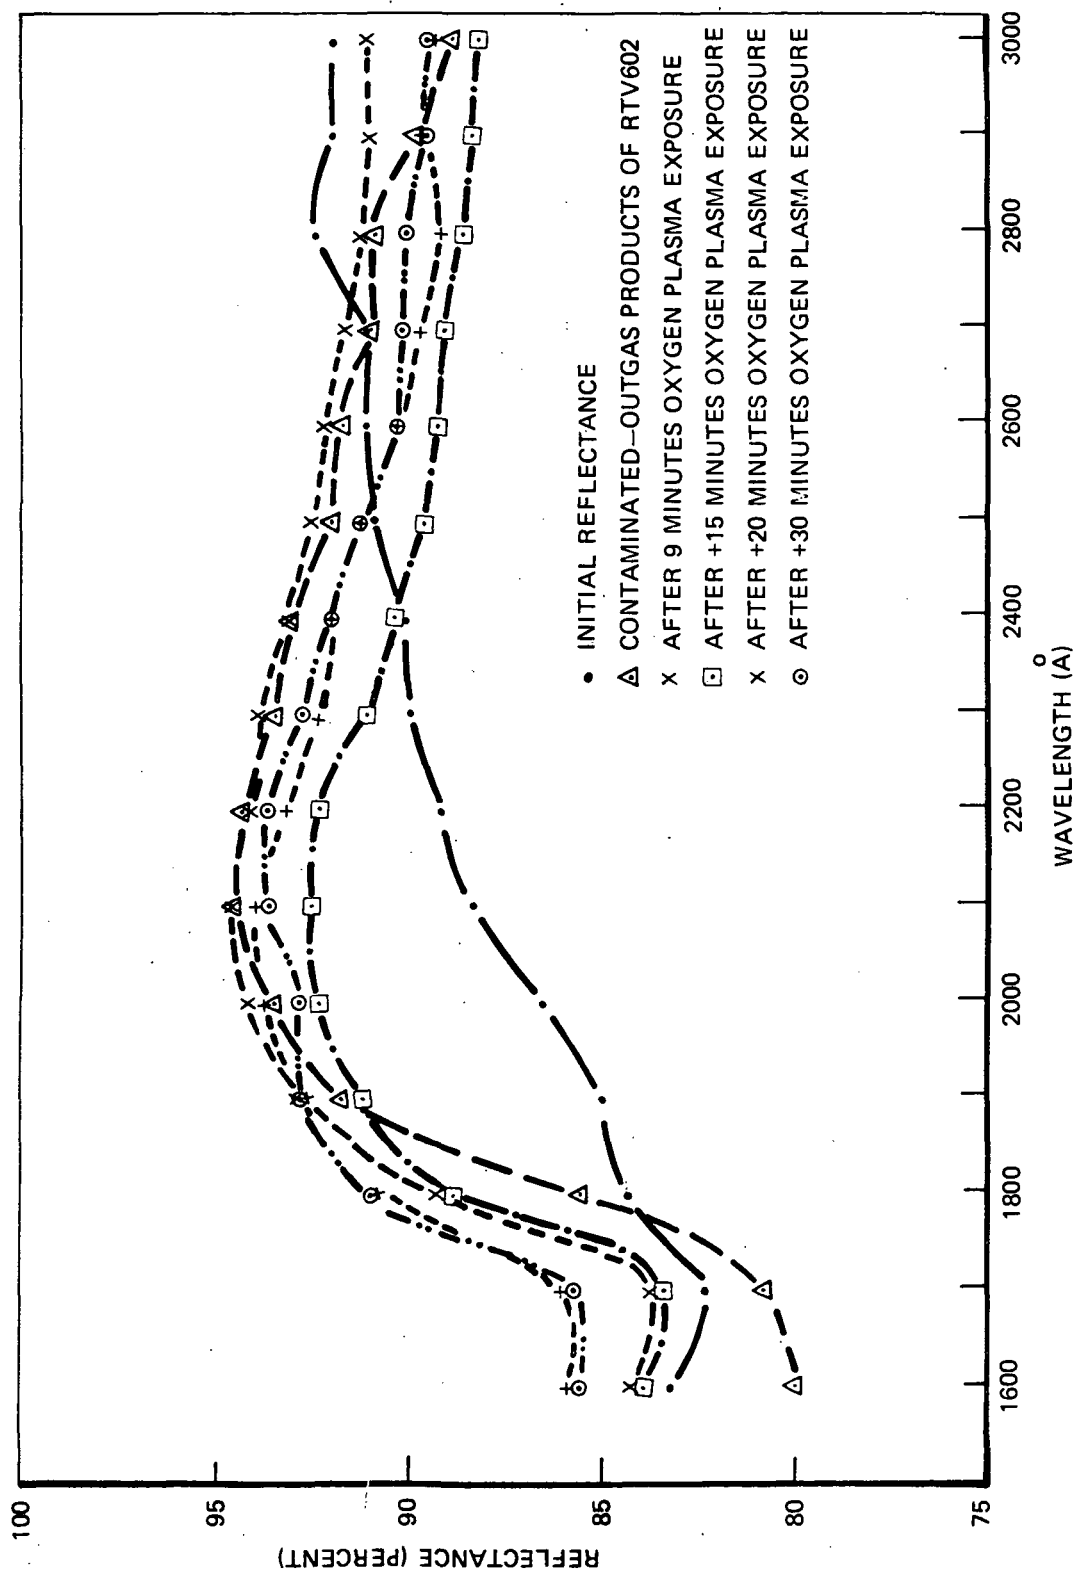
Figure 15: REFLECTANCE DATA FOR HgF_2/Al MIRROR (HgF117)
